Technical Service Bulletin

**1XL - ONE PERSON LIFE RAFT, ORAL INFLATION SYSTEMS
INSPECTION AND REPAIR**

ISSUE DATE:	March 23, 2011	TSB NUMBER	TSB-10-003 Rev B
--------------------	----------------	-------------------	------------------

This Technical Service Bulletin applies to all TUL One Person Life Rafts, Type 1XL, NSN 4220-21-846-5885, p/n 6152.

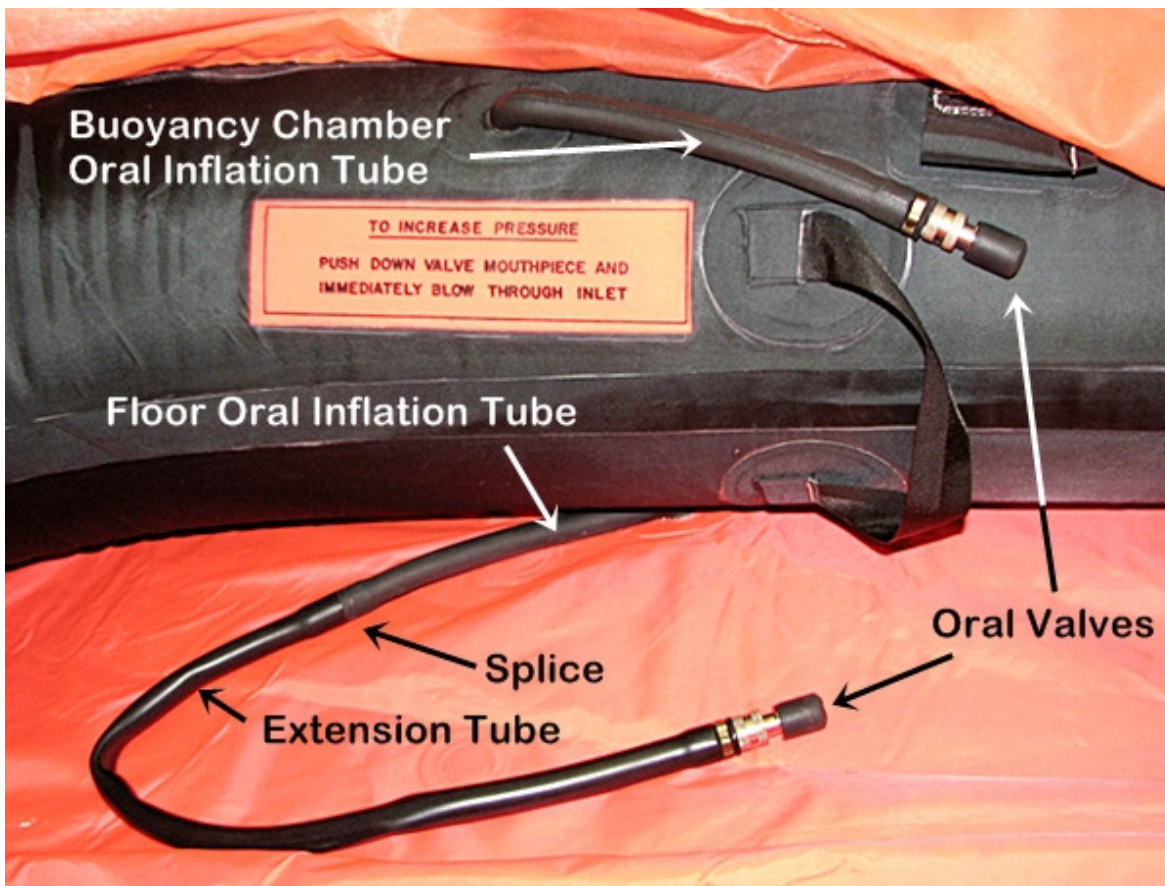
Figure A, Oral Inflation Systems

As part of the regular inspection and inflation testing of the raft, perform a **thorough** visual examination of the two molded oral inflation tubes shown in Figure A.

Particular attention is to be given to signs of cracking, splitting, deep abrasions, permanent collapsing, permanent folding and age hardening. If either of the two molded oral inflation tubes does not pass the damage assessment, the raft is to be sent to Tulmar Safety Systems for oral inflation tube replacement.

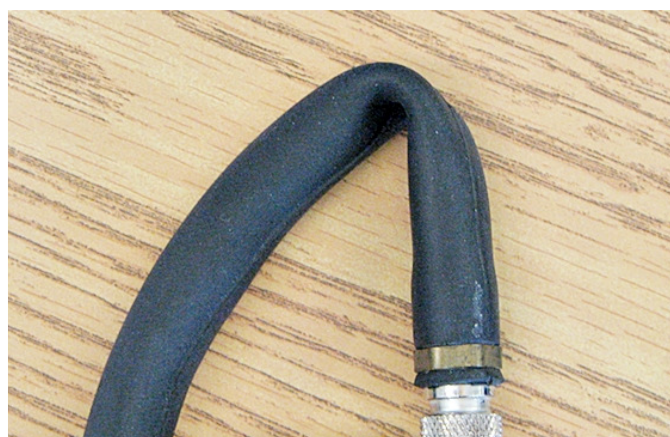
Figure B, Oral Inflation Tube with permanent fold

Figure B shows an example of an oral inflation tube that must be replaced because the tube may fail at the location of the permanent fold once the tube is forced straight or during inflated conditions.

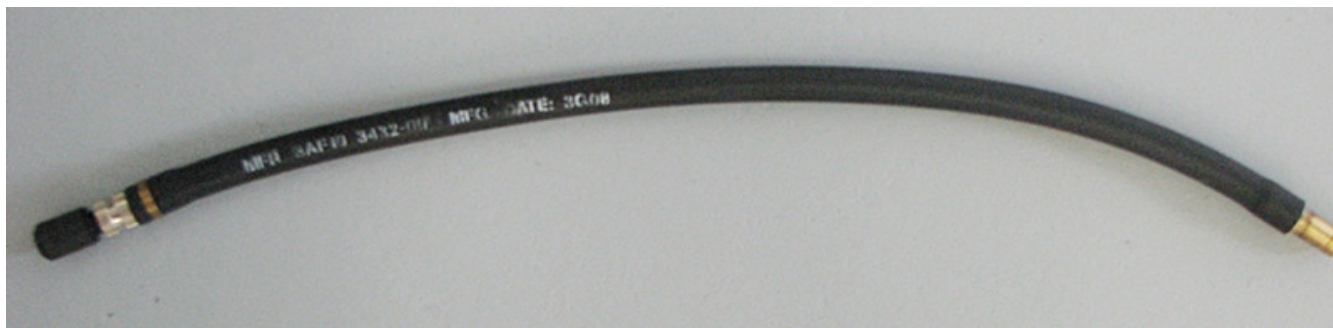
Figure C, Extension Tube Repair Kit

Pre-assembled repair kits include a new rubber tube, pre-glued brass splice coupling at one end and a pre-crimped oral inflation valve at the other. Part number and Mfg Date are marked as shown in Figure C.

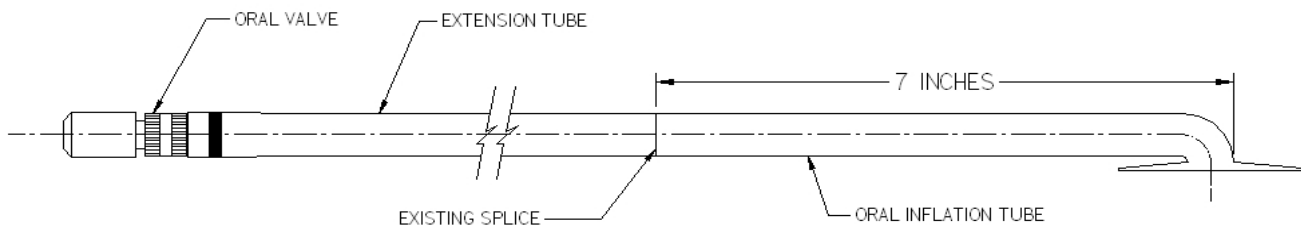
Figure D, Length of Original Oral Inflation Tube

Floor oral inflation systems may have been repaired prior to this Technical Service Bulletin, and as such, the oral inflation tube portion may have already been shortened. It will be necessary to first measure the length of the oral inflation tube in order to determine the appropriate repair kit. The length of the original oral inflation tube is 7 inches measured from the outside of the 90° elbow, as shown in Figure D.

If the oral inflation tube measures 7 inches as shown above (+/- 1/2 inch), obtain the 1st repair kit and proceed to the **Repair Instructions**.

If the oral inflation tube measures approximately 6 inches, get the 2nd repair kit and follow the repair instructions.

When the oral inflation tube measurement around 5 inches, repair the oral inflation system using the 3rd repair kit

If the oral inflation tube measures 4 1/2 inches or less, the raft is to be sent to Tulmar for complete floor oral inflation system replacement.
