Technical Service Bulletin

Hammerhead Life Preserver

ISSUE DATE:	January 07, 2022	TSB NUMBER	TSB-22-001
--------------------	------------------	-------------------	------------

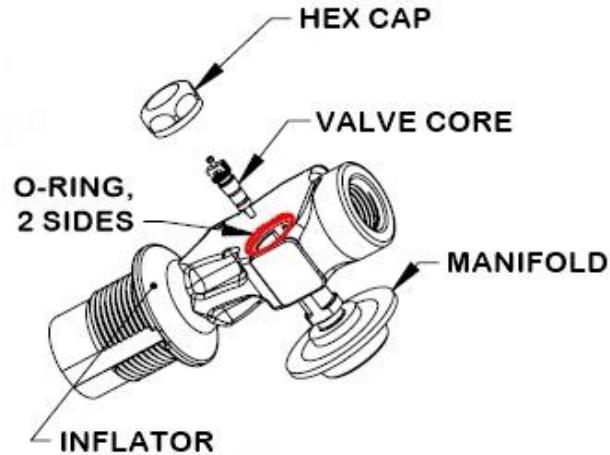
Figure 1, Inflator and manifold assembly

manifold, and pushes past the valve core, ultimately inflating the life preserver bladder. O-rings located each side of the inflator body keep the compressed gases within the inflator body during the brief inflation phase. Degradation or displacement of the O-rings could result in CO₂ escaping the inflator body during inflation, resulting in an underinflated life preserver.

While the shelf life is 15 years from Date of Manufacture, service life of the rubber O-rings is shorter. The O-rings are captive and not exposed to atmosphere and UV rays, so degradation is not rapid or significant. Nevertheless, as a precautionary measure the O-rings are to be replaced as part of the periodic maintenance inspection and any time a mechanical inflator is separated from the valve manifold. Removing the hex cap is sufficient to compromise the seal therefore the O-rings are to be replaced in this scenario as well. There are two O-rings per inflator and two inflators per Hammerhead Life Preserver.

There are two O-rings per inflator and two inflators per Hammerhead Life Preserver. Replace with Tulmar Safety Systems Inc p/n 3251-105, O-Ring, Manifold. (4 required per life preserver).
